Assessment of subsidence induced damage to masonry buildings

Alfonso Prosperi^a, Paul A. Korswagen^a, Mandy Korffa^{a,b}, Jan G. Rots^a

^a Delft University of Technology, Faculty of Civil Engineering and Geosciences

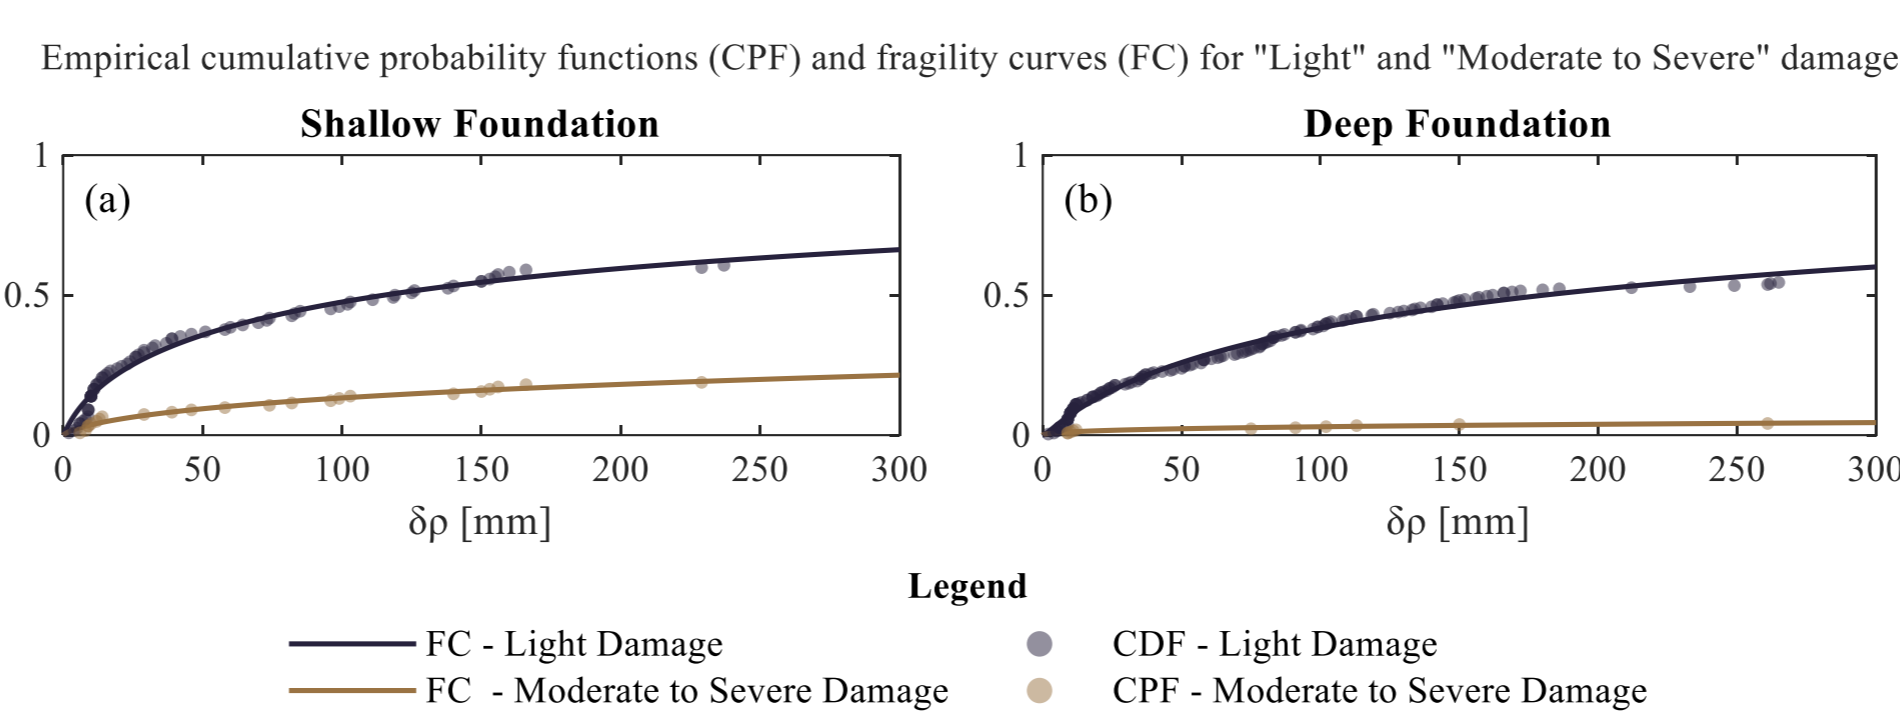
Figure 2. Fragility curves of buildings resting on shallow or deep foundations for all the differential settlement δ_p . "Light damage" refers to aesthetic damage characterized by very fine/fine cracks up to 5 mm. "moderate to severe damage" implies moderate and severe damage that could affect the serviceability of the building or be associated with a risk for the structural safety (from: Prosperi et al., 2023).

To obtain an empirical picture, a rich dataset was collected in a digital database comprising 386 surveyed masonry buildings located in the Netherlands, 122 of which rest on shallow foundations and 264 on piled foundations. The analyses allowed for the retrieval of empirical fragility functions; These display the probability of reaching or exceeding damage as a function of a settlement-related parameter (e.g. differential settlement in Fig.2).

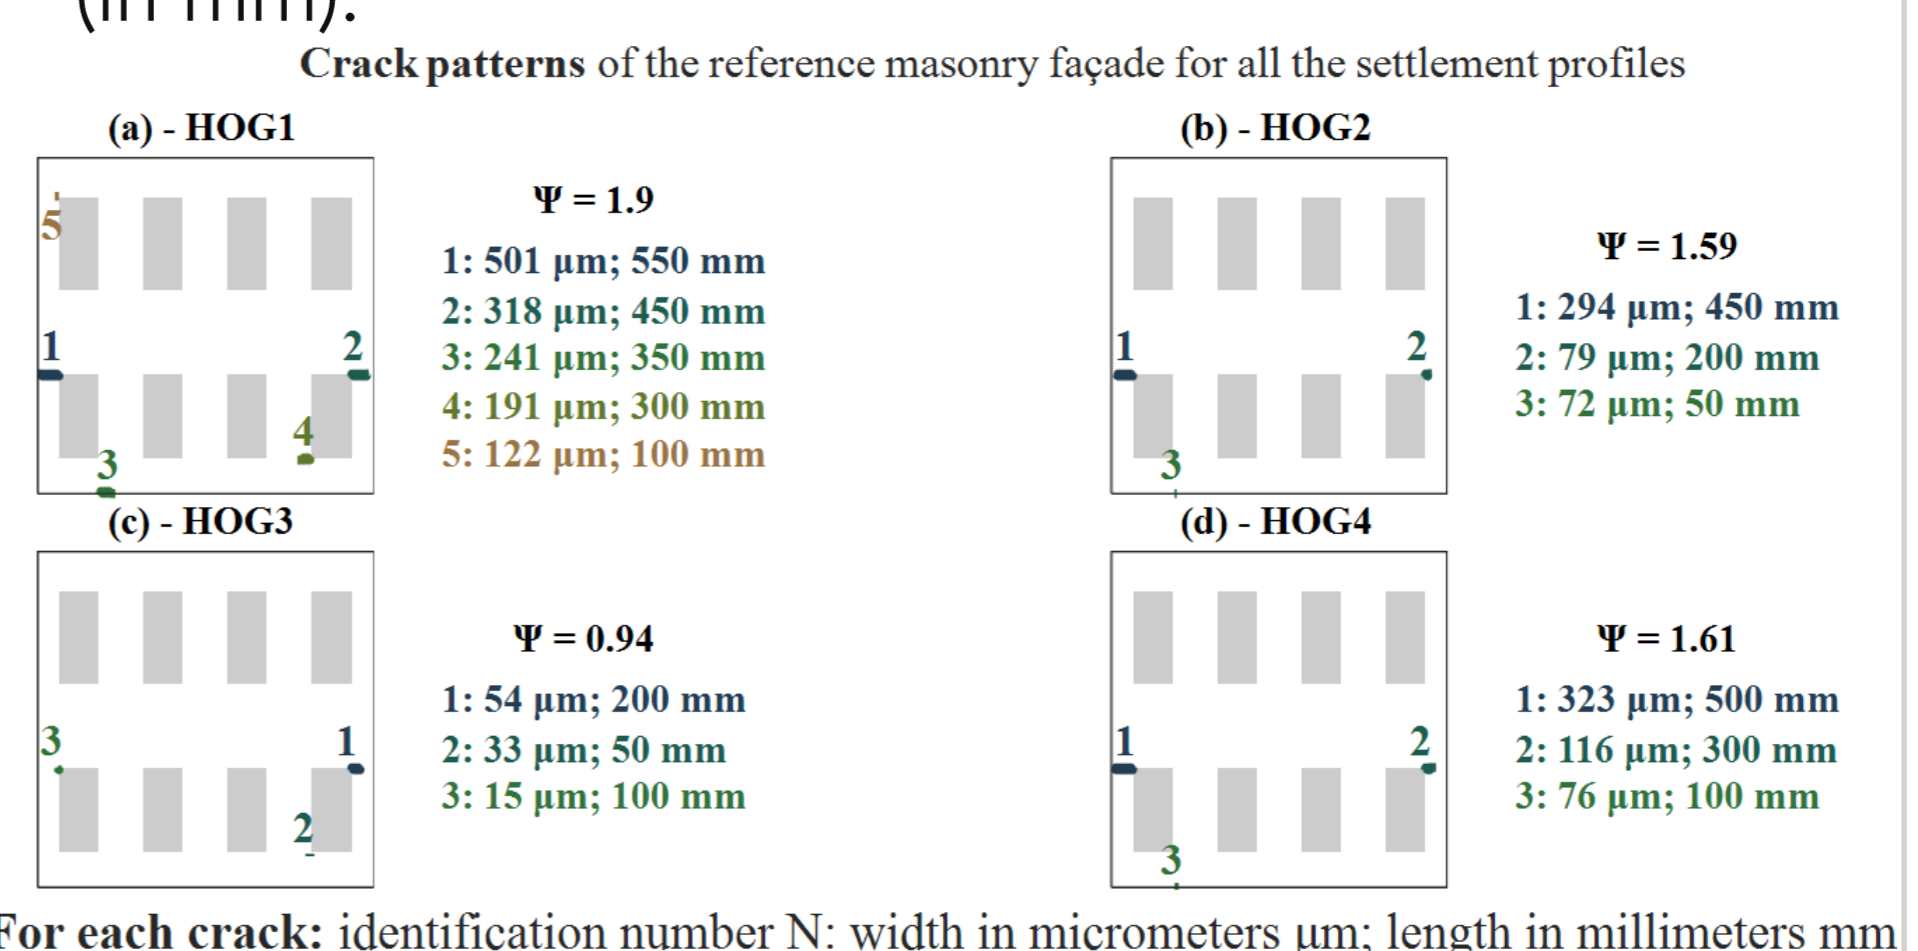
For each crack: identification number N: width in micrometers μm ; length in millimeters mm

Figure 5. Crack patterns of the masonry façade for all the settlement profiles (HOG1-4).

The results of the numerical analyses can be used to directly and objectively assess the extent of the induced damage in each wall of the building. The parameter Ψ in equation (1) proposed by Korswagen et al., 2019 is used to quantify the damage in the numerical models in one single scalar value:

$$\Psi = 2 n_c^{0.15} \hat{c}_w^{0.3} \quad (1)$$

Where n_c is the number of cracks, \hat{c}_w is the width-weighted and length averaged crack width (in mm).
