Potential damage of land subsidence to the built heritage

Living On Soft Soils – Work Package 3.2

LOSS Symposium

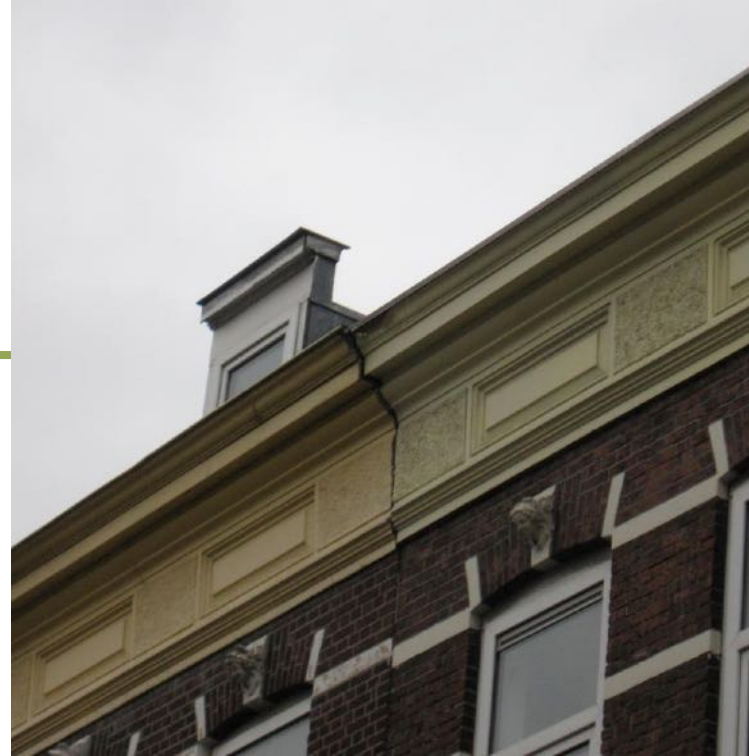
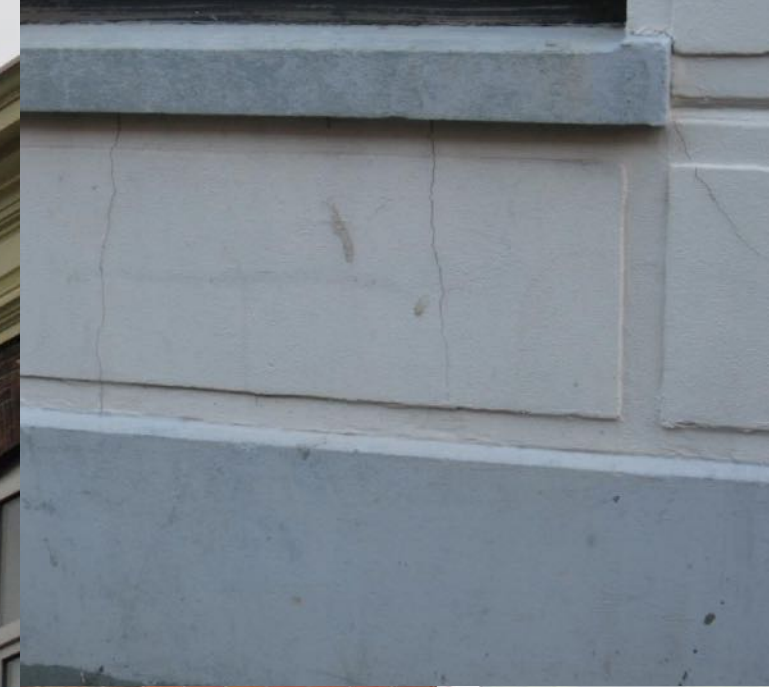
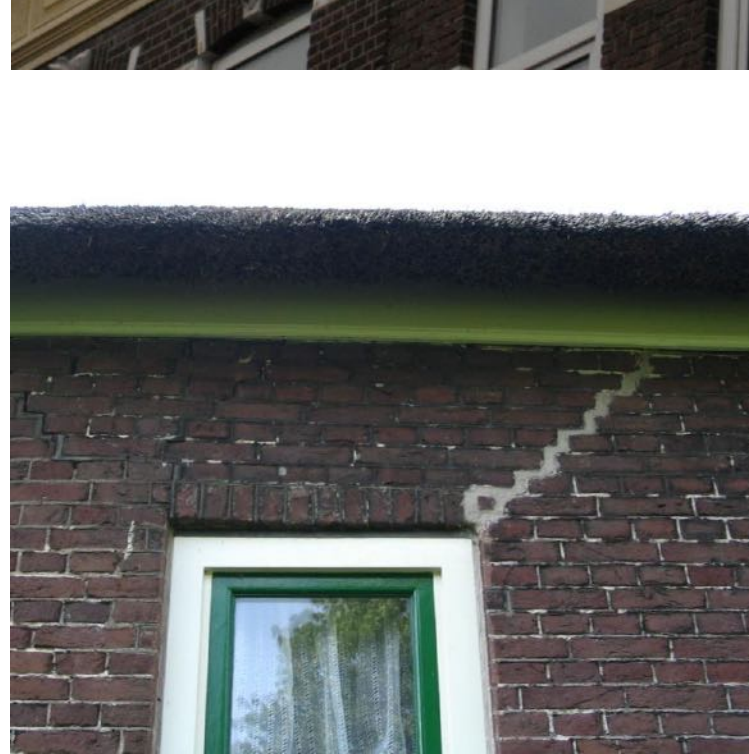
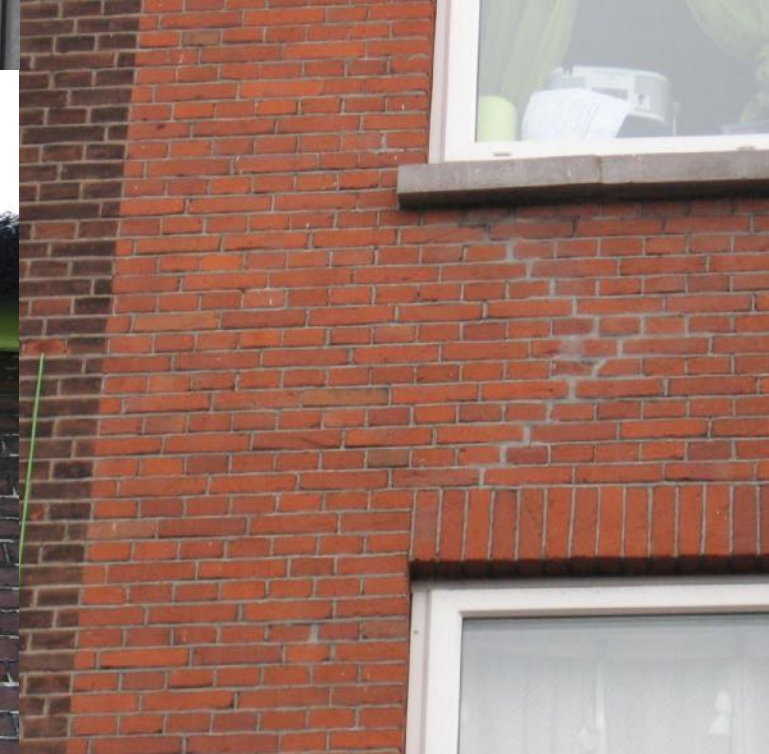
Aesthetic damage involves fine cracks that can easily be treated during the regular maintenance works.

The cracks are visible on inspections and may also involve finishing and decorative features.

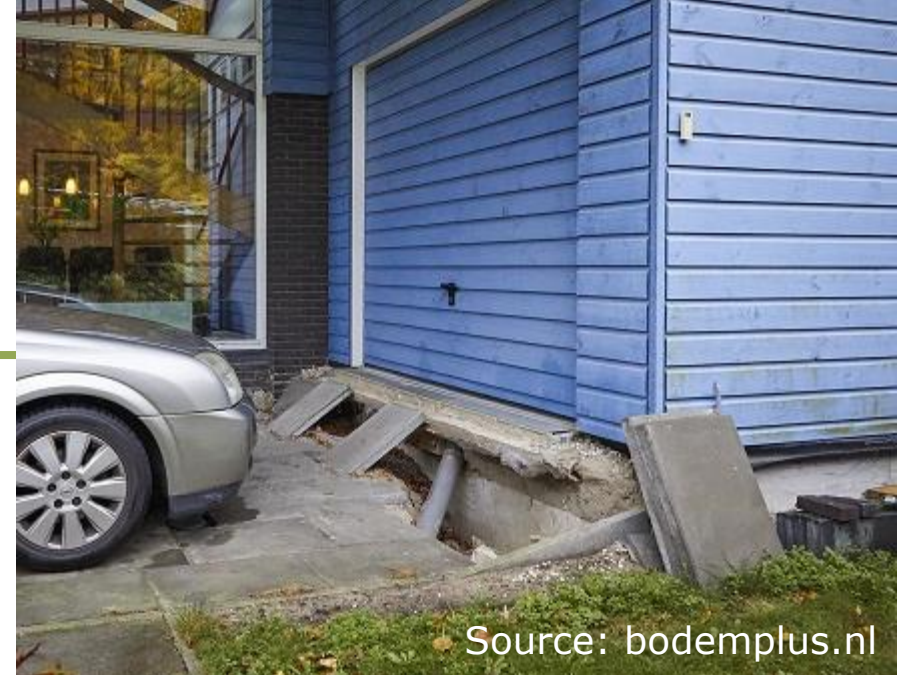
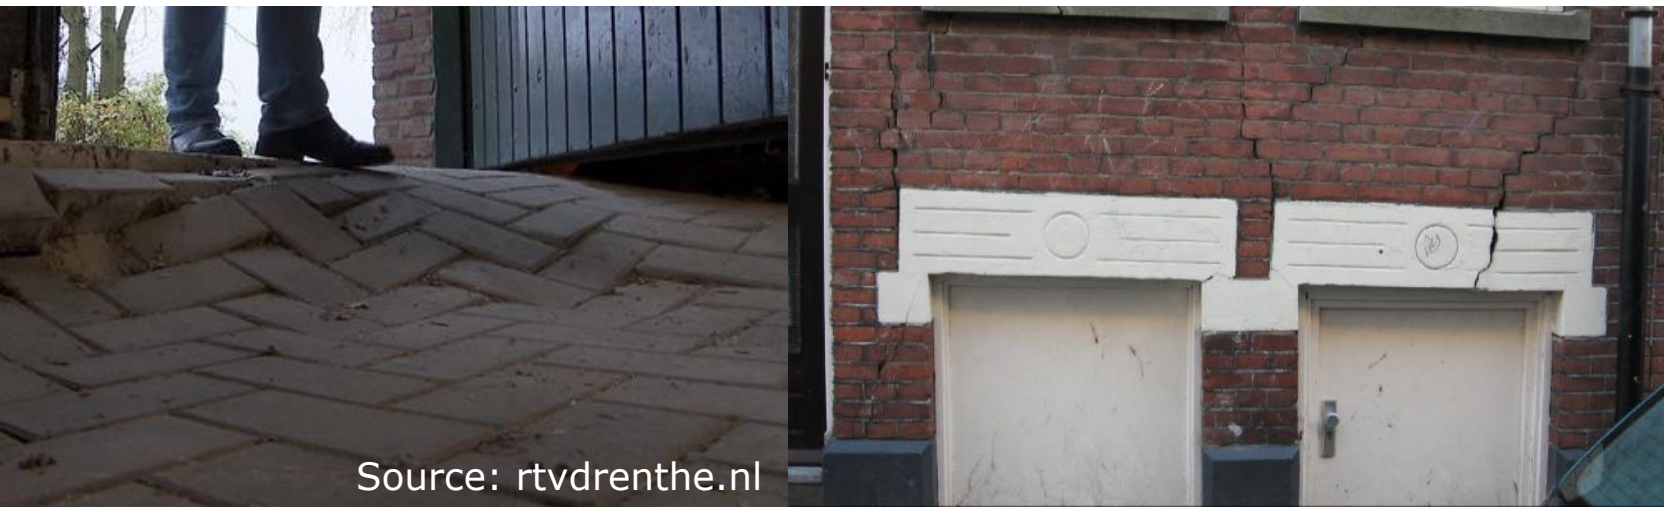
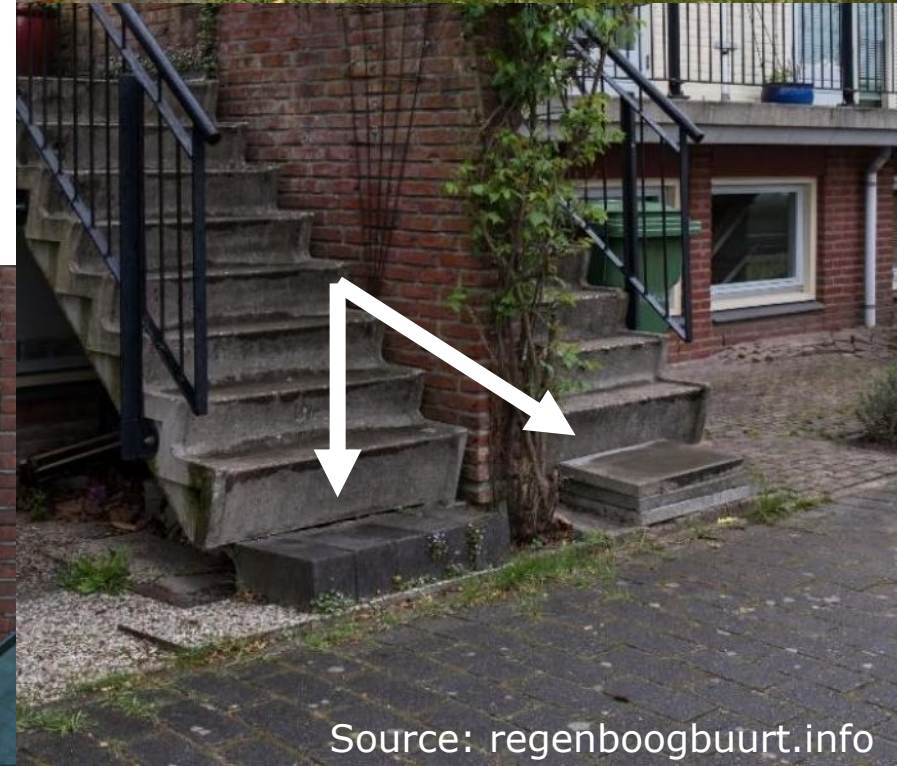
Functional damage is defined by any harm to the functionality of the building or parts of it.

Examples includes the jamming of windows and doors, accessibility problems and damages to the underground services.

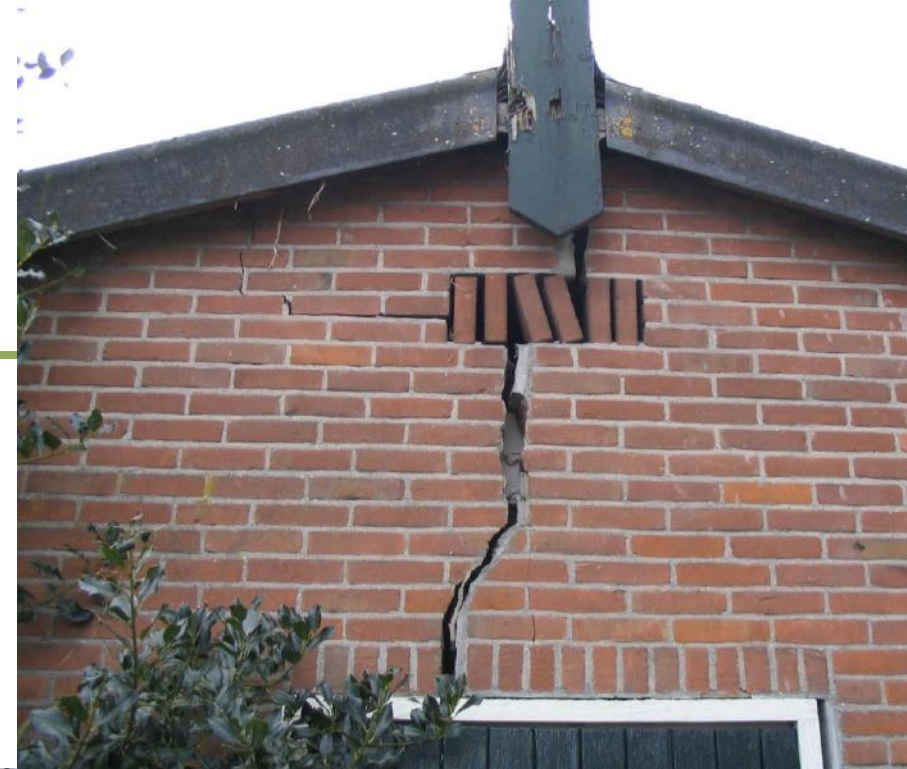
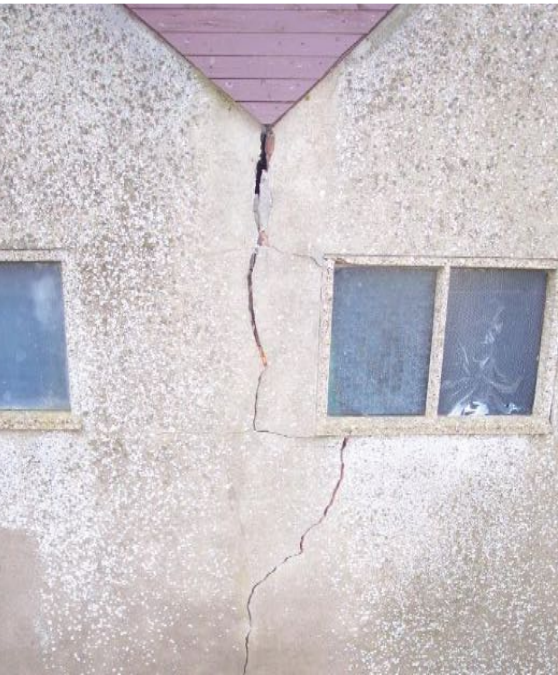
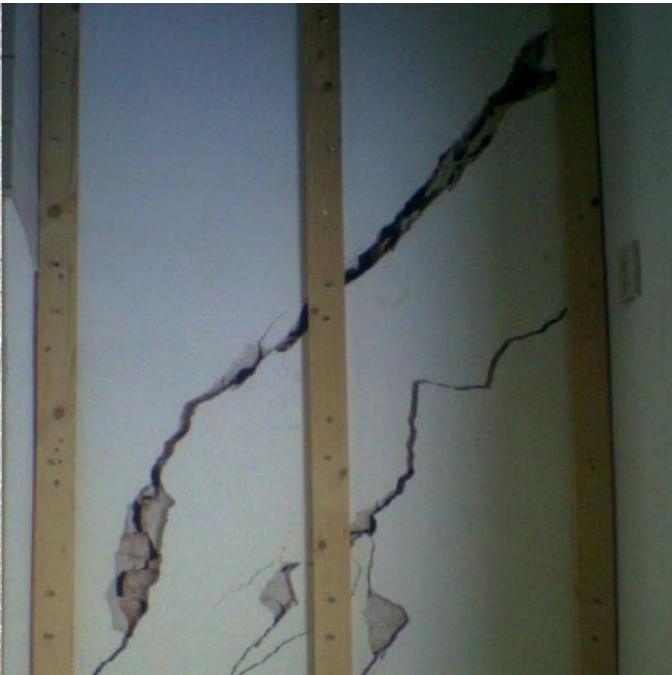
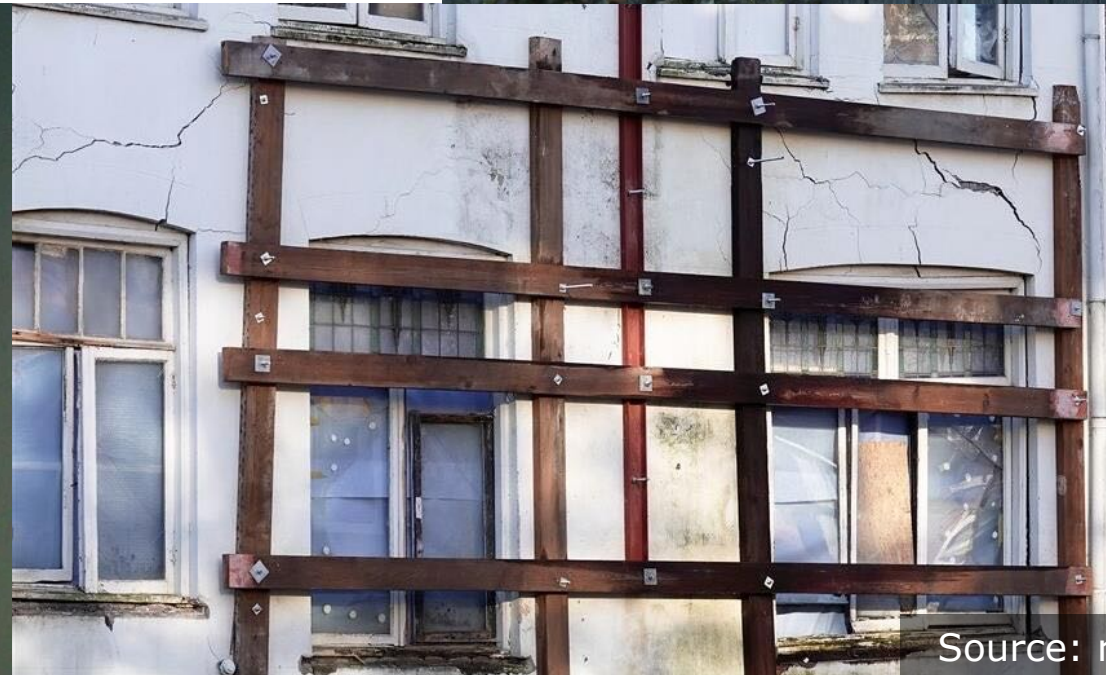
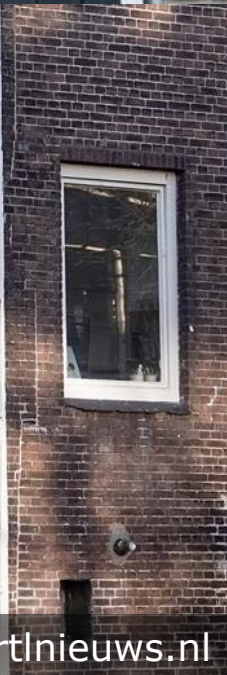
Structural damage affects the strength of the building or of part(s) of it. Extensive repair work is required and, in some cases, the complete rebuilding.

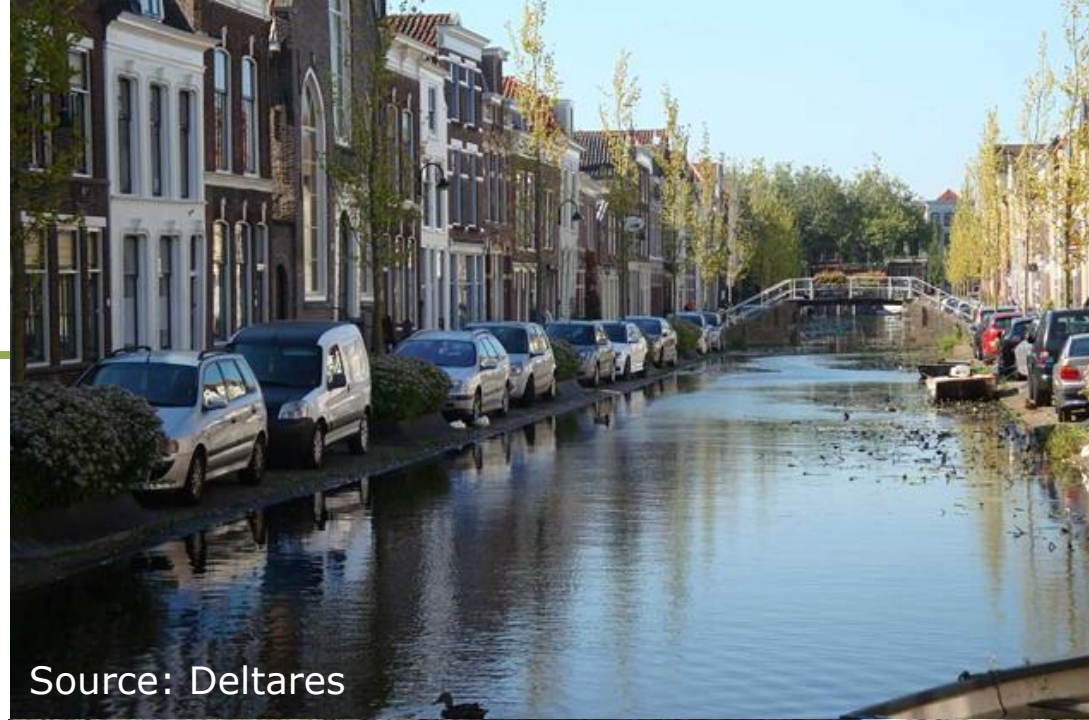
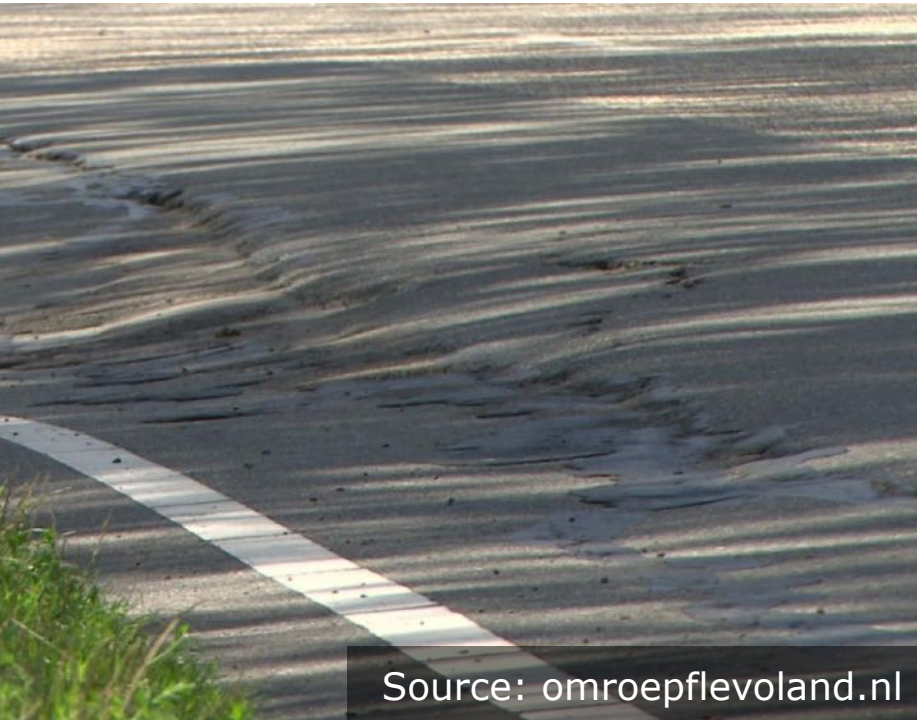
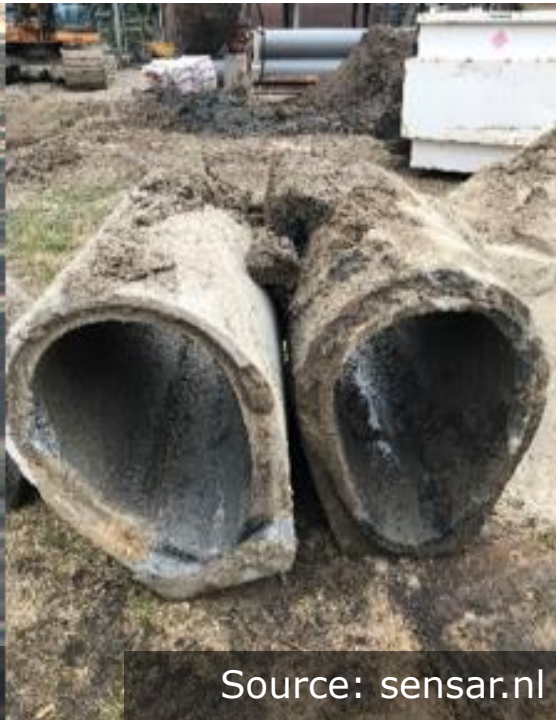
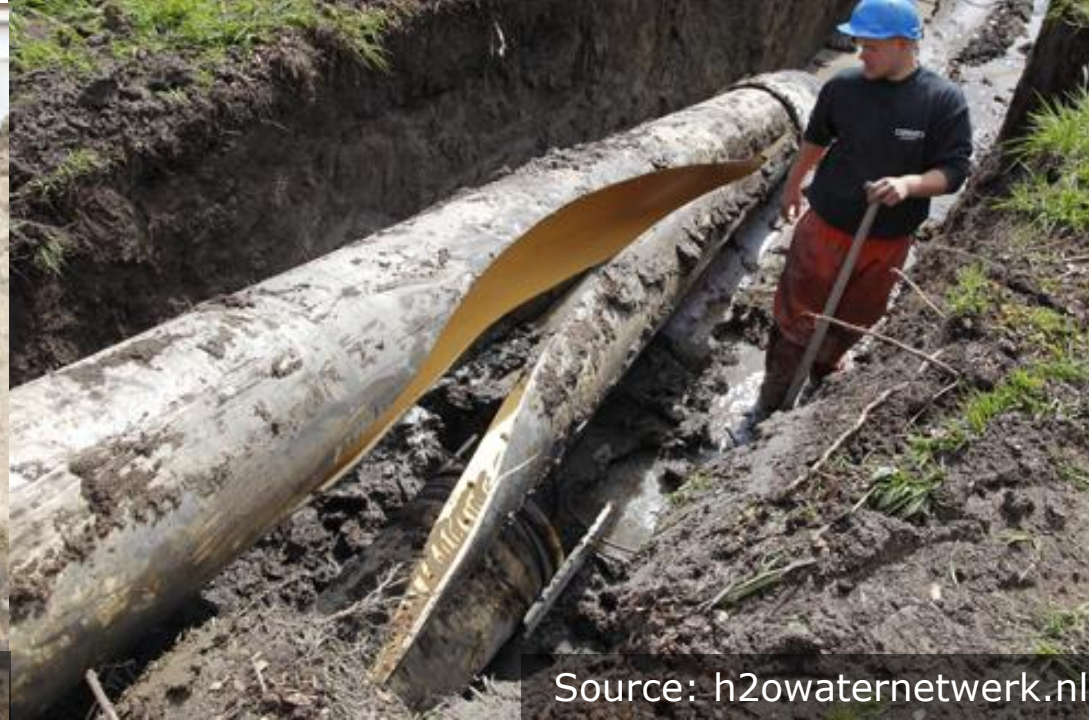
Damage to infrastructure

Subsidence results in damage to **roads, pavements, sewers, water supply networks** and **gas pipelines**, that require maintenance and management strategies.

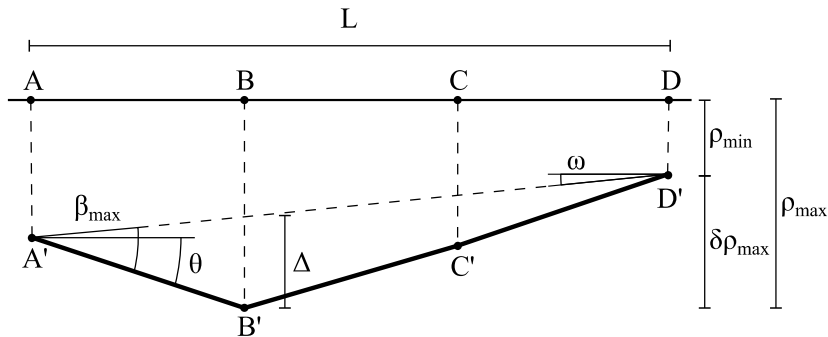
Digitalized settlement profile:

Four parameters were computed for each building and they were related to the severity of the observed damage:

- **Differential settlement** $\delta\rho$;
- The **rotation** θ ;
- The **relative rotation** β ;
- The **deflection ratio** Δ/L .
